University Sidewalk Reconstruction: Root Control

Posted November 2012

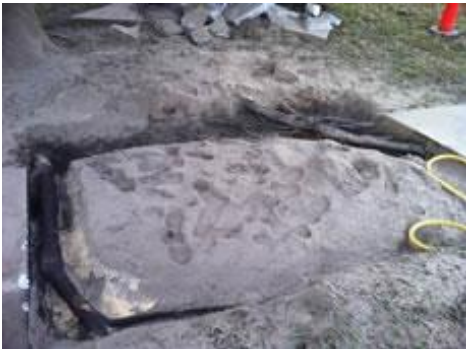
Figure 1: Roots

The UCF Tree Team is at it again, this time fostering cohabitation of trees and urban sidewalks at a busy intersection. Large roots of a maturing Live Oak behind the University of Central Florida sign on University and Alafaya have been pushing up slabs of sidewalk, resulting in a tripping hazard. Instead of utility cutting roots and damaging the structural integrity of the tree or removing this majestic piece of UCF, tree team members taught the tree a lesson in cooperation with a technique called root guiding.

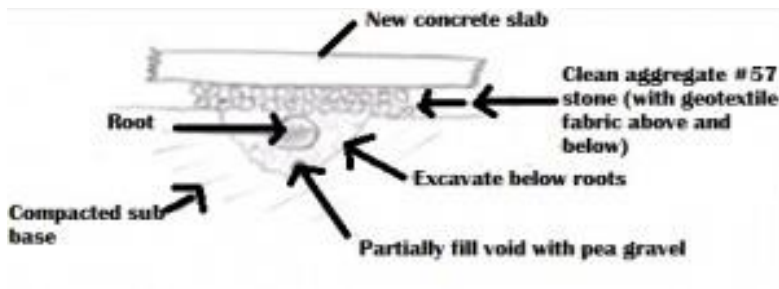
Figure 2

This technique (Figure 2) gently coaxes the trees roots in a pre-determined path of least resistance by using aggregate stone as a cushion. In this fashion, the tree's roots will naturally expand down into the porous aggregate stone instead of up into the denser concrete slab. Due to the duration of time since the roots have been growing underneath the sidewalk, a slight reduction of root girth was necessary. This reduction allowed the concrete to lay flush with the other slabs, while still allowing the functionality of the tree's roots.

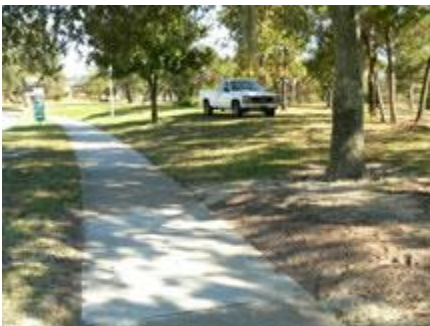
Sidewalk after root excavation
